**Hydroacoustic Investigations
of Diamond Lake
Spring 2003**

Prepared for the
Oregon Department of Fish & Wildlife
Roseburg, Oregon

JC Headwaters, Inc.
Bend, Oregon

June 19, 2003

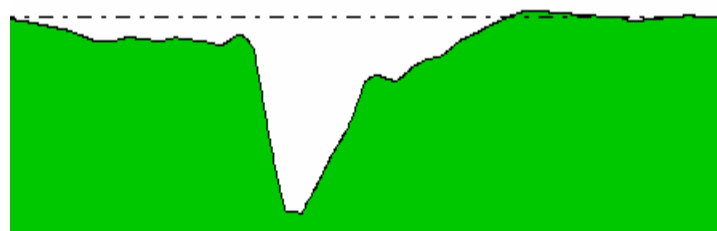
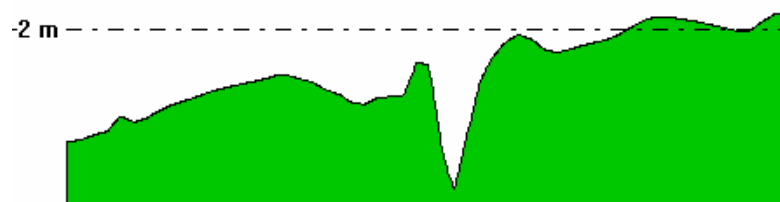
Figure 5. Cross-sections of the old channel in Diamond Lake starting from closest to the shore (1) towards the lake center (6). Units are in meters.

The results for the channel mapping are shown in Figures 1-5. The channel is still relatively intact, although some areas of channel sidewall slumping were evident. The figures of the map show the substrate without the presence of the macrophytes, which are abundant through substantial portions of the channel. Note that the channel terminates before the lake edge and the section of about 25 m in length appears to have been filled in following the completion of the lake treatment in 1954.
